Manhole Inspection Summary

Manhole # S17E1_008MH

Insp Date: **5/14/08 2:48 PM**

Location Address: **2811 maudlin av**

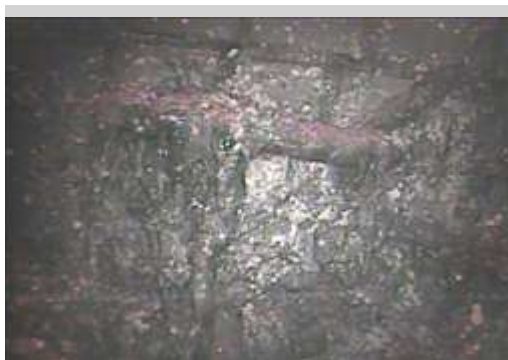
Defect 3

☒ **Evidence Of Surcharge** Depth: **3** (ft.) ☐ Active Surcharge Present

surcharge evidence

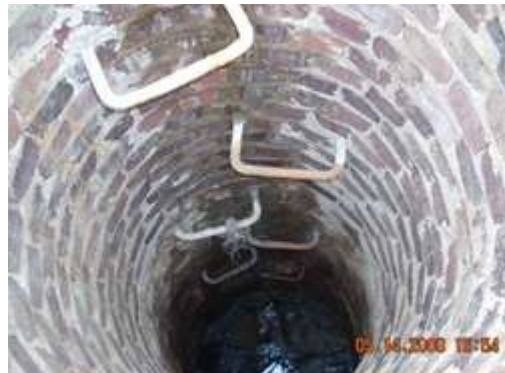
Defect 2

Condition: ☐ Sound ☐ Cracked ☐ Root Intrusion ☐ Deteriorated ☐ Leaks ☒ **Debris**

Count: **8** Missing: **1** ☒ **Corroded**

corroded & missing steps, bench debris,
channel debris

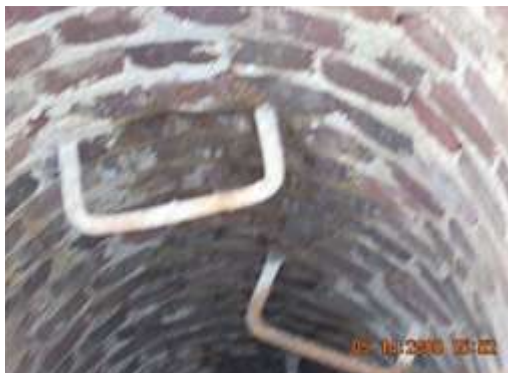
Defect 1

Infiltration: ☐ None ☐ Joint ☐ Cracks ☐ Mortar ☐ Roots ☒ **Wall**

infiltration @ corbel wall

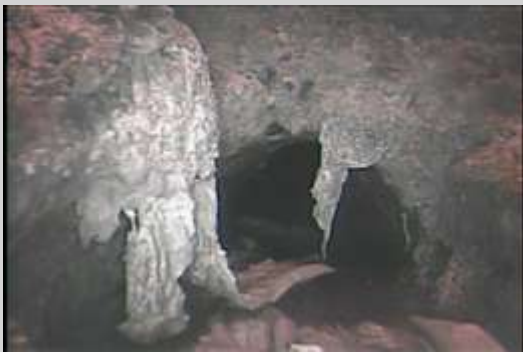
12 O'Clock Outflow

Pipe Height: **8.4** (in.) Rod and Bar (Angled)
Pipe Material: **Clay** ☐ Pipe Lined
Invert Depth: **15.75** (ft.) Flow Characteristics: **Slow**
Deposits: ☐ None ☐ Mud ☒ **Sludge** ☐ Debris ☒ **Grease**
Silt Depth: **4** (in.) Deposits Extent: **Heavy**
Infiltration: **None** Pipe Seal Cond: **Unknown**

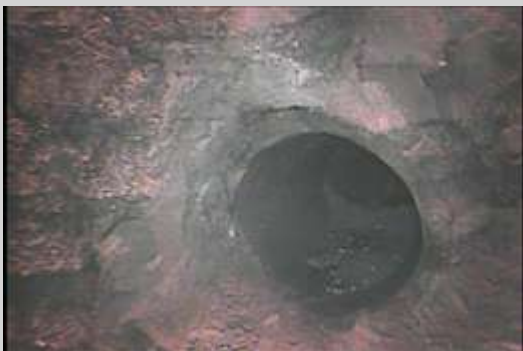
3 O'Clock Inflow

Pipe Height: **8.4** (in.) Rod and Bar (Angled)
Pipe Material: **Clay** ☐ Pipe Lined
Invert Depth: **7.88** (ft.) Flow Characteristics: **Fast**
Deposits: ☐ None ☐ Mud ☐ Sludge ☐ Debris ☒ **Grease**
Silt Depth: **4** (in.) Deposits Extent: **Heavy**
Infiltration: **None** Pipe Seal Cond: **Unknown**

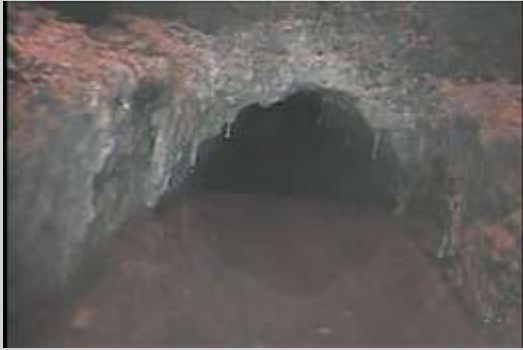
7 O'Clock Inflow

Deposits: ☐ None ☐ Mud ☐ Sludge ☐ Debris ☒ **Grease**

Silt Depth: **2** (in.) Deposits Extent: **Medium**

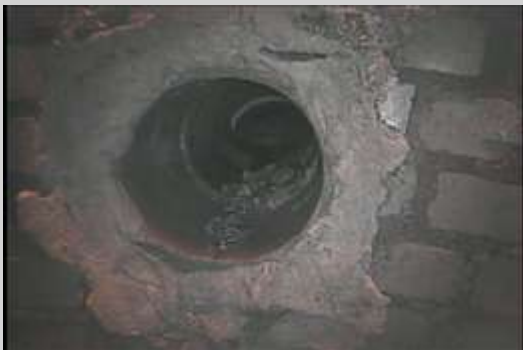
9 O'Clock Inflow

Deposits: ☐ None ☐ Mud ☐ Sludge ☐ Debris ☒ **Grease**

Silt Depth: **2** (in.) Deposits Extent: **Light**

Infiltration: **Runner** Pipe Seal Cond: **Broken**
